## PRECEDENCE 1 INSPECTIONS

## **CCPIA**

## 1234 Main Street North Las Vegas, NV 89031

Buyer Name 11/11/2024 9:00AM

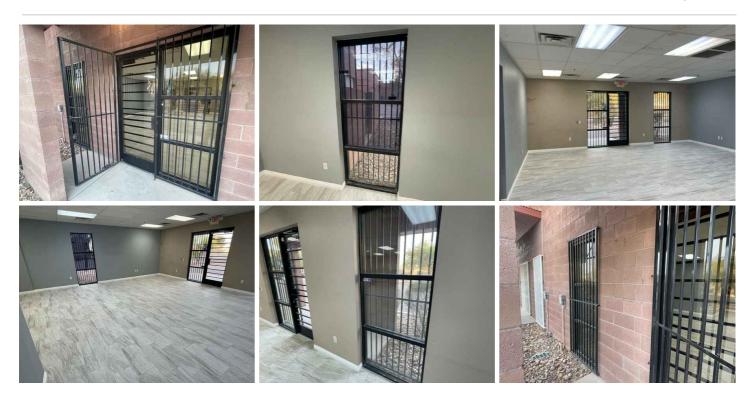
Window trim exhibited moderate weathering and deterioration commensurate with its age.

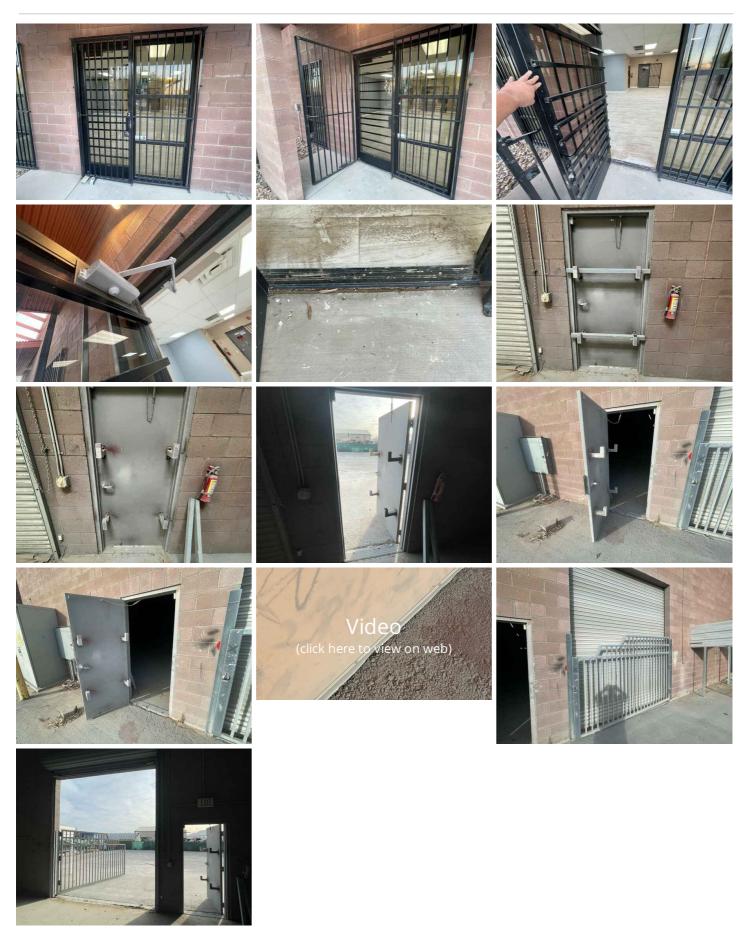
Door exteriors showed general \*Minor/Moderate\* deterioration commensurate with their age.

Contact a qualified professional.

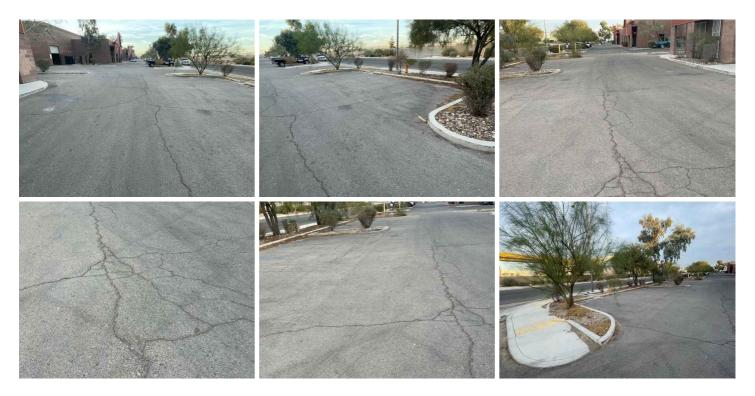
Common cracks (1/4-inch or less) were visible in the driveway. Cracks exceeding 1/4 inch (6 mm) should be filled with an appropriate material to help reduce continuing damage.

Contact a qualified professional.

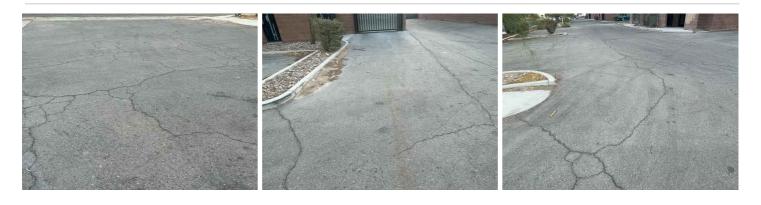
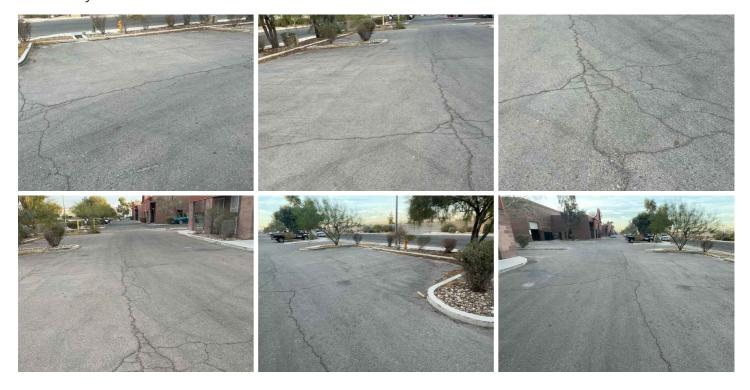
6.2.2 Driveway

The concrete driveway had shrinkage cracks. Shrinkage cracks commonly occur as newly-placed concrete dries. They are surface cracks that are not a structural concern.

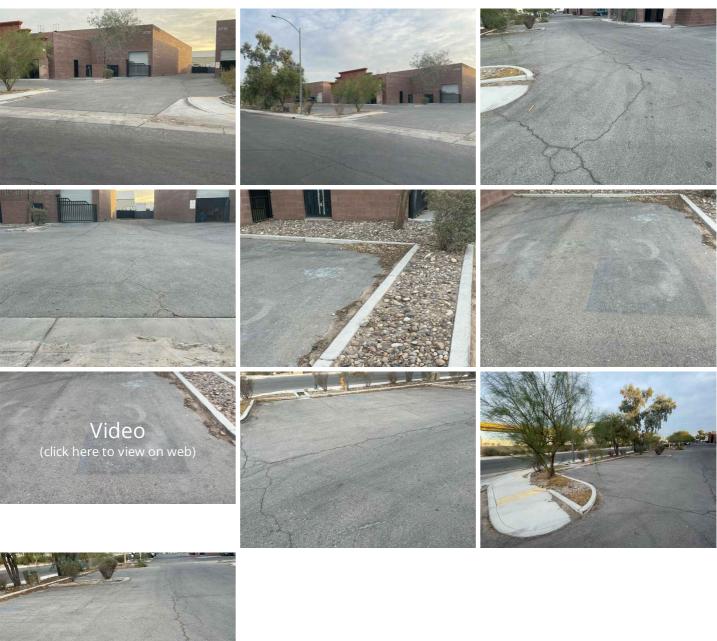
#### 7.3.2 Markings

Parking lot striping was generally severely worn, faded and illegible in areas. Parking lot should be restriped.

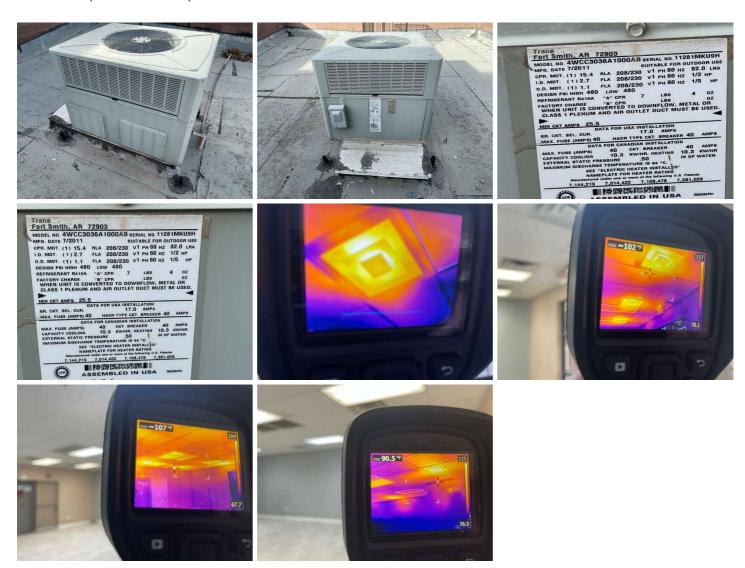
Furnace should be cleaned and serviced annually. Recommend a qualified HVAC contractor clean, service and certify furnace.

Contact a qualified HVAC professional.

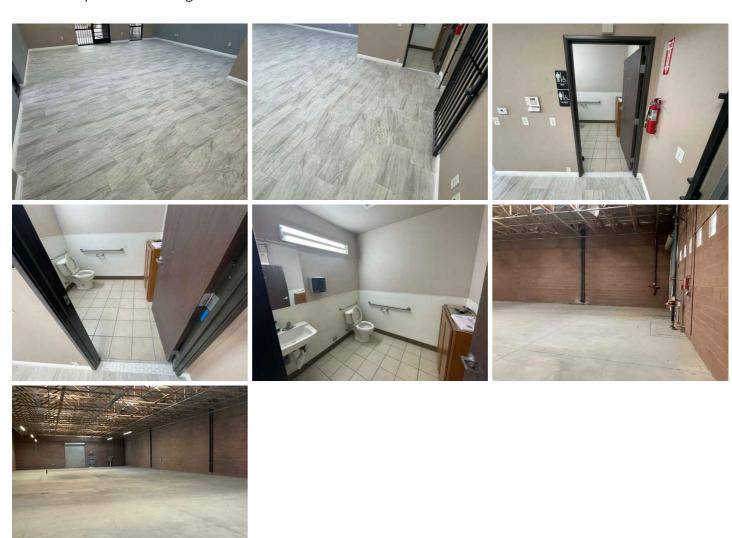
Floors in the property exhibited moderate surface wear along major paths of travel. Recommend a qualified flooring contractor evaluate for possible re-finish.

Contact a qualified flooring contractor

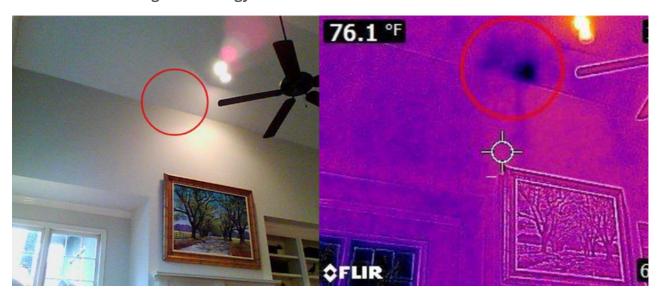
#### **General: Thermal Image Technology**

#### Thermal Image Photography

Thermal imaging captures an image based on the wavelengths of light that have a lower frequency than light that can be seen with the human eye. A thermal camera uses a special sensor in its lens that can see only the visible light of the infrared spectrum, which is based in part on the temperature of the object viewed.
